FACT SHEET 2- Coil Slump

FS2-Revision 1 : 30 July 2020

Coil Slump

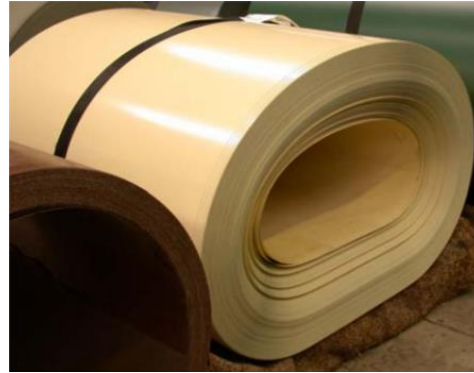
Coil slumping or collapse is where the coil cannot hold-up its own mass and maintain the integrity of its cylindrical shape when it is stacked on its horizontal position (Figure 1). In particular, the inner bore of a slumped coil is distorted from a circular cross-section, and subsequent handling of the coil is impeded.

Figure 1: Coil slump (horizontal position)

- However, if customers want to store the coils in bore horizontal storage position, then please refer to the following storage guidelines:
 1. Bore horizontal multi high storage (i.e. two or three high storage of bore horizontal coils using loosen wooden chocks for restraint) is not recommended due to increased risk of coil slump.

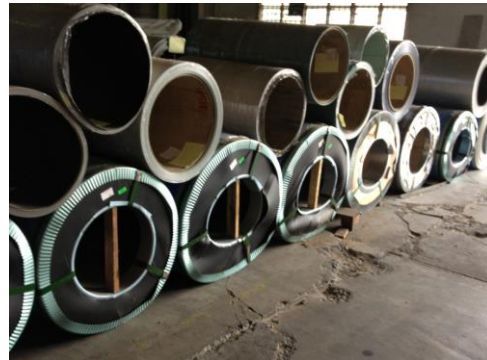
- Improper floor surface e.g. uneven, no level or very smooth concrete surface (Figure 2).
- Stacking over two-high and relying on an inadequate means of coil support.

Figure 2: Improper coil storage areas

7. Ensure the coil storage area is even or flat. Stored the coils with adequate end-stops and properly designed chock as illustrated in the Figure 4(b):

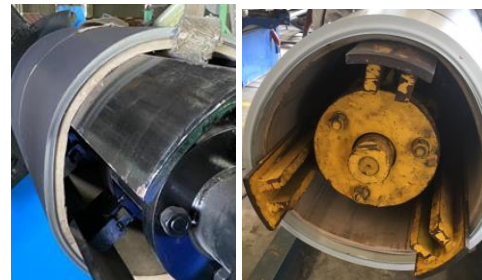
- Loose of coil tension (inter-wrap slippage) due to frequent start-stop operation during roll-forming.
- Over or under expanded mandrel causing inconsistent torque transmission from mandrel to coil (Figure 3).

Figure 3: Over expanded mandrel caused by inconsistent torque transmission from mandrel to coil.

2. Handle the coils gently to avoid “Shock Loading” phenomena.
 3. Avoid any accidentally coils dropped on the floor during coil transferring process.
 4. Ensure the uncoiler mandrel in good condition and expanding in optimum position to avoid any inconsistent transmission of torque from mandrel to the coil.

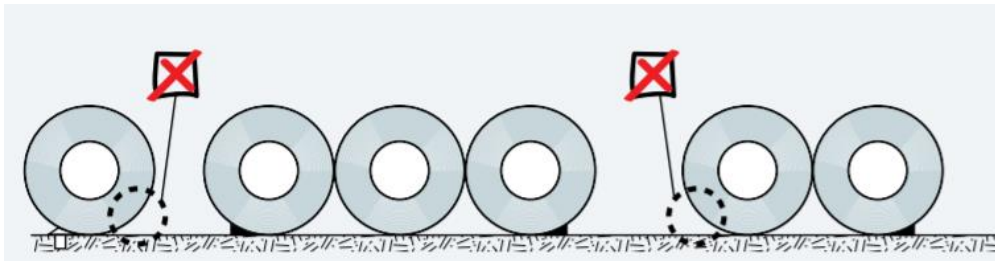
- Insufficient, lack of or inaccurate placement chocks (Figure 4a).
- Failure to use either adequate end-stops or a properly designed chock to constrain coil product.

Figure 4a: Unacceptable or inappropriate coil restraint

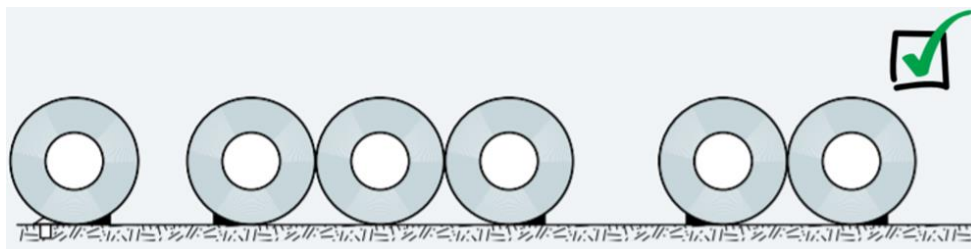
Figure 4b: Same coils with acceptable or appropriate restraints
