# FACT SHEET 1- Scuffing & Galling

FS1-Revision 1 : 30 March 2020

The objective of this fact sheet is served as a reference of surface defects which could be generated during the handling of coated and painted steel coil, strip and roll-formed sheets.

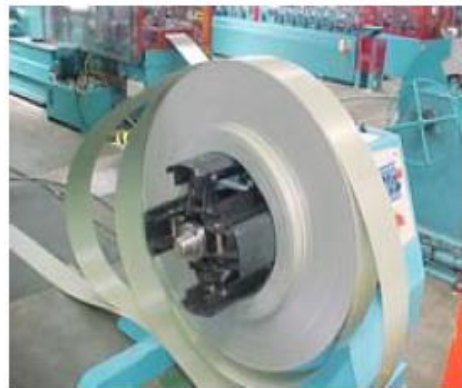
Scuffs are small comet shaped gouges that can occur as an odd scuff or cluster of scuffs. A scuffed area is brighter than the surrounding surface and occurs on both surfaces. Scuffs can vary in severity and can affect a few metres or a number of tonnes mainly in the bore of coils.

Scuffing occurs when there is movement between wraps in a coil. This can occur during coiling or uncoiling operations. When an uncoiler generates loose outer wraps, this material tends to slide within inner wraps rather than uncoiling process.

When uncoiler experiences rapid speed change (acceleration or deceleration) this could cause wraps movement within the coil. Over time, this can generate scuffing defects and cause coils to sag or collapse.

Scuffing can occur during processing where roll speeds are mismatched with the strip feed. In case of roll-formers where there are many rolls and strip can be contacting more than one point on a roll (different diameter = different speed) there is potential for roll speed to mismatch strip speed.

- To reduce inserting the coil too frequent into the recoiler/uncoiler
- Ensure there was no mismatched roll speed during the roll-forming process

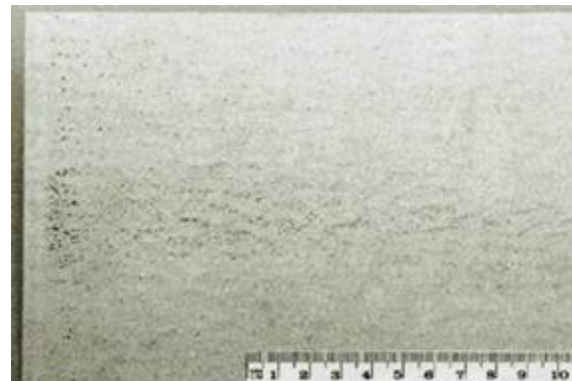
Galling can occur if there is coil movement during transport. This is exacerbated if coils have been poorly chocked or cradled or placed on hard and uneven surface ( such as steel checker plate) resulting in pressure point.

Bore horizontal coil that’s are frequently moved can result in galling, this is more likely to occur if coil storage is substandard such as if racks or chocks have pressure point, coils stacked or stored on uneven or poorly maintained floor.

Sheets packs (flat sheets or roll-formed panels) with poor loading and transportation practice can also result in galling of sheets. If the sheets packs loaded on the truck was loaded with heavier item on top of the sheets, it will generate galling on the sheet pack due to pressure point.

Galling on coated products

Good coil handling and storage practices kindly refer to the guidelines Storage and Handling BlueScope Product based on the following link:
